Title: Multi-Site Fatigue Testing and Characterization of Fuselage Panels from Aging Aircraft Structure

## Multi-Site Fatigue Testing and Characterization of Fuselage Panels from Aging Aircraft Structure

Sandeep R. Shah<sup>1</sup>, Todd B. St John<sup>1</sup>, Ian L. Pryce, Jr.<sup>1</sup>,  
Gregory A. Shoales<sup>2</sup> and James M. Greer, Jr.<sup>2</sup>

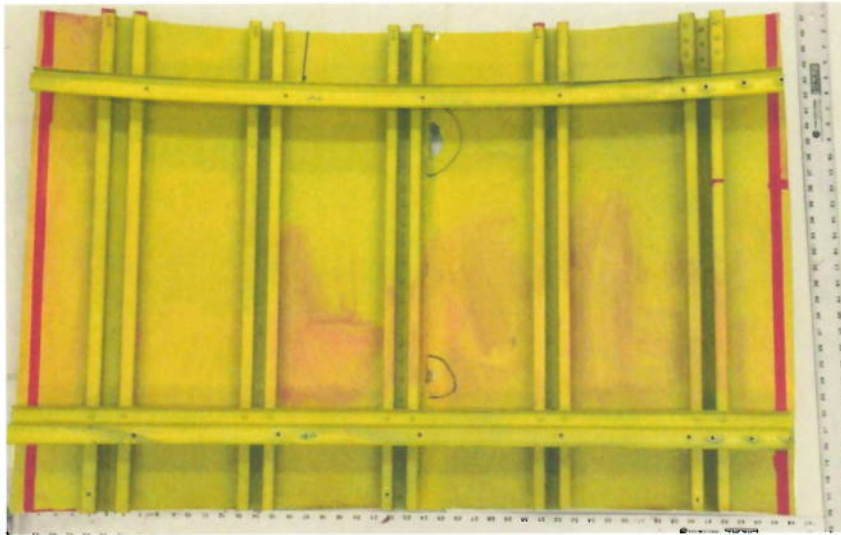
**Figure 1:** Photo showing as-removed section for the residual life testing (scales in inches).

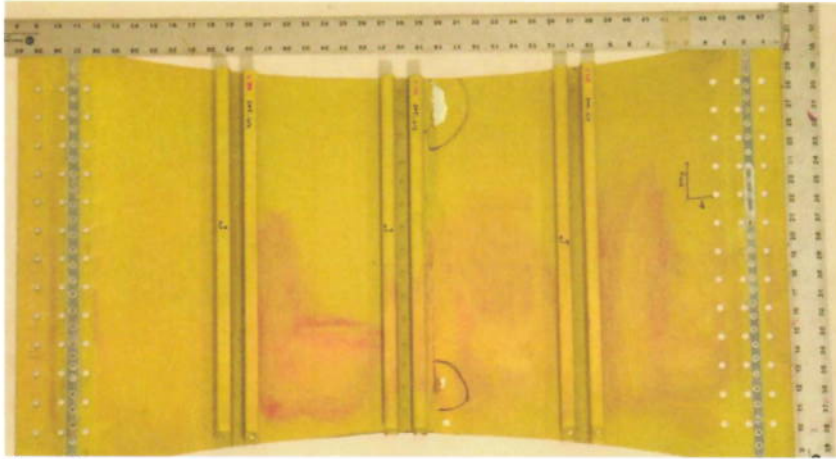
**Figure 2: Photo showing the prepared test specimen after machining from the received section of Figure 1 (scales in inches).**

The fasteners at the edges of the panel were replaced with next-oversize fasteners with a slight interference fit to prevent crack initiation from edge fasteners. The machined specimen was then instrumented with strain gages. Five strain gages were applied just above the lap joint and five were applied just below the lap joint. They were equally spaced along the width of the specimen and measured the strain in the two skin panels of the lap joint. The specimen was then gripped in steel grips with 3/8 in SAE grade 8 bolts and nuts. These steel grips gradually tapered to 125 mm (5 in) or 150 mm (6 in) tabs, which were gripped in either 500,000 N (110 kip) or 1,000,000 N (220 kip) capacity servo-hydraulic test frame (MTS – Eden Prairie, MN, USA) respectively. The test specimen assembled in the grips was then mounted in the test frame, with tabs of the grips held in the hydraulic wedge assembly of the test frame as shown in Figure 3. The strain gages were monitored using a separate data acquisition computer running LabView from National Instruments (Austin, TX). The load and displacement of the ram were monitored by the control computer of the test frame. The proportional analog output was taken from the machine's controller and fed to the LabView computer for storage.

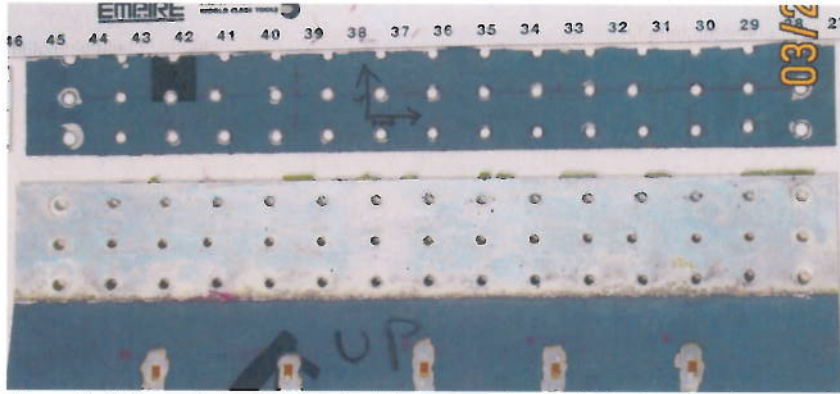
The panels were carefully investigated after failure to identify the locations of fatigue damage and to determine where panels failed under overload due to accumulated damage leading to fast fracture. It was easy to identify these features optically, as the fatigue regions showed planar fracture surfaces oriented predominantly perpendicular to the loading axis, while the fast fracture region was characterized by dominant shear lips. Figure 6 shows a panel immediately after failure. It can be seen that the top panel of the lap joint has failed at the topmost

row of the fasteners, while the bottom panel has remained intact. The unsymmetric lap joint creates an out-of-plane load eccentricity such that the topmost row of the fasteners experiences the maximum flexural tensile load due to tension loading. This additional load makes the topmost row of fasteners more susceptible to failure. For most panels, failure occurred at this location. Some panels, however, had spot welded doublers in the lap joint, creating dual laps in one lap joint. Such panels primarily failed by the failure of the topmost row of the spot welded doubler. Again the topmost row of the spot welds experiences higher stress due to the eccentric loading and is therefore the first to fail.

**Figure 6: Failure of the test panel at the top most row of the fasteners (nearest the scale; scale in inches). It can be seen that the bottom panel is completely intact.**

Table 1 lists the size of the cracks emanating from each fastener hole along the failed fastener row, shown in Figure 6, in which the 15 holes are numbered from left to right ("1" being the left-most hole). Cracks emanating from the left side of the hole are simply labelled with the hole number. Cracks emanating from the right side of the hole are labelled with a "b" suffix (e.g., 14b). The crack lengths are represented in  $a$  and  $c$  dimensions, where  $a$  is the length of the crack along the face of the skin and  $c$  is the length of the crack in the thickness direction of the panel. Where  $c$  is marked as  $t$ , it indicates that the crack has grown through the thickness of the panel. As seen from this table, fastener holes 1 and 15 showed no sign of fatigue cracking. They are the outermost rivets and, as mentioned earlier, these rivets were replaced with the next oversize rivet and were assembled with some interference specifically to avoid the crack initiation at these locations arising from edge effects. Video indicated the crack originated between fastener numbers 13 and 14. Analysis indicates the crack started from the left side of Hole 14. A few of the cracks from this panel with their identifying crack numbers are shown in Figure 7.

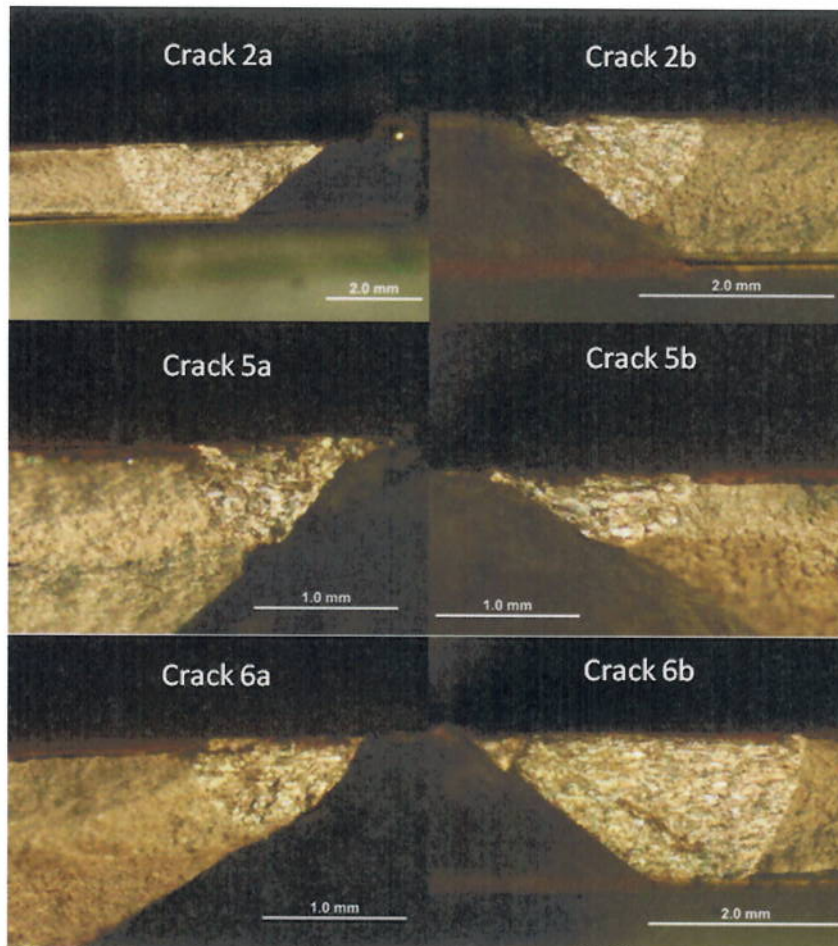
Figure 7 shows the cracks emanating from fastener holes 2, 5 and 6 of the failed panel shown in Figure 6. It can be seen that this panel had multi-site damage prior to its final failure. Close examination of Figure 7 reveals that all the cracks initiated from the knife edge of the countersink hole. This knife edge, due to its sharpness, has a higher stress intensity factor. Note also that the bottom of the countersink is in close proximity to the bottom panel of the lap joint. The actual initiation site could be due to fretting with the bottom panel, but detailed microstructural examination is beyond the scope of the present work. Data have been compiled for 14 panels in similar fashion. Furthermore, we have also created SolidWorks models for each panel showing the location and the extent of each crack. Figure 8 shows the SolidWorks model where the cracks are superimposed at the fastener hole locations.

**Figure 7:** Stereomicrographs of the cracks emanating from fastener holes 2, 5 and 6. The shiny surfaces are the fatigue cracks and the dull surfaces are the fast fracture regions.

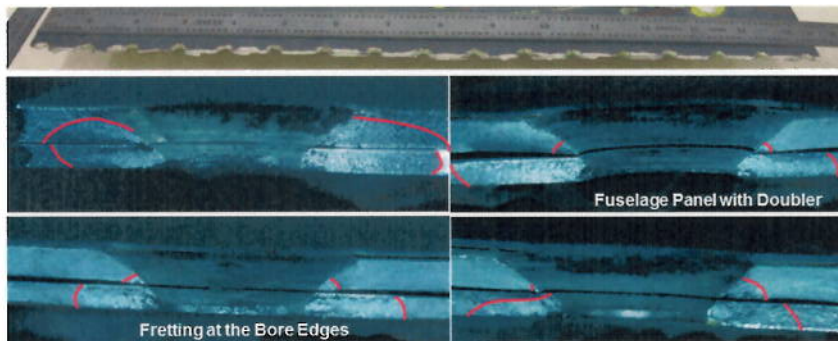
In some instances, doublers were found to have been used in the lap joint configuration. In such cases, the failure occurs in both panels and crack lengths are different from those seen in the welded panels. Figure 9 shows the failure of the panel which had a spot-welded doubler on the top panel. While the failure occurred at the fastener row of the lap joint, it can be seen that the crack propagates quite differently in both panels. The crack does not initiate from a common point of two panels, even though fretting is observed there. The cracks in this case are emanating from the bottoms of both of the panel skins. The bottom edge has a knife edge due to the countersinking operation. These knife edges are the initiation sites for both of the panel skins. Also, the lengths to which the cracks grow are different for the two panels. This is truly a case of multi-site damage (MSD) and multi-element damage (MED) which, when taken together, constitute wide-spread fatigue damage (WFD). It can be seen that this change in configuration has taken the simple case of MSD in one row of fasteners (previous case) to a much more complex one having the effects of inter-panel fretting and differential knife edges from a single countersinking operation. The fretting also indicates the presence of burrs from the countersinking operation. The panels were first spot welded and then machined to create the countersink for the fasteners. This machining operation appears to have left burrs and allowed some chips to become lodged between the two panels, leading to fretting. Modelling details all of these scenarios would be a very daunting task. The aim of the present work is therefore to create the database of panel failures and their crack locations and dimensions. The data are compiled in a similar manner as described above for all 14 test panels and are available to use for any kind of modelling. Detailed knowledge of the stress spectrum would also be required.

**Figure 9: Failure of fuselage panels with spot welded doublers. It can be seen that the damage progresses in the two panels quite differently. In both panels the crack initiates from the bottom, where the countersink forms a knife edge.**
